Wyoming State Capitol

Condensate System and Ventilation Study

October 11, 2002

CATOR, RUMA & ASSOCIATES, CO.

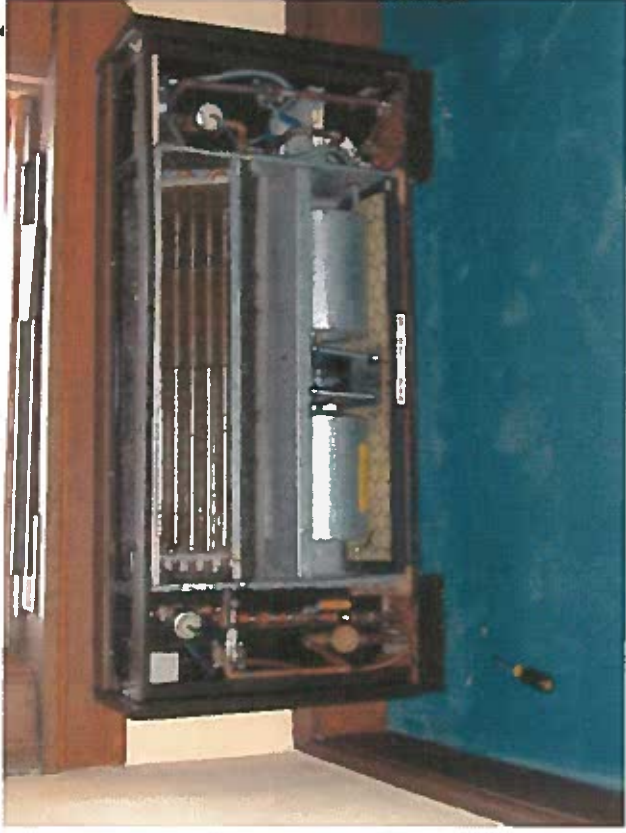
Typical Fan Coil Unit

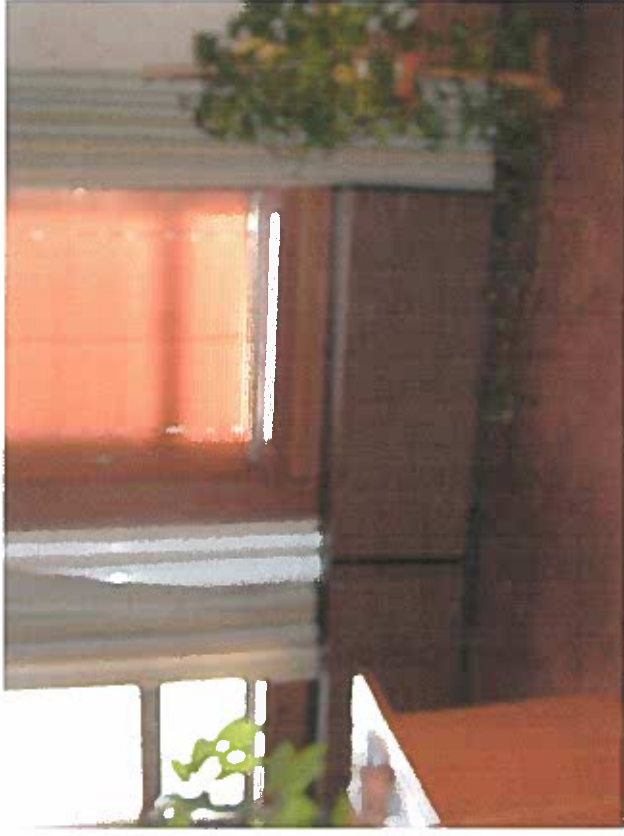
Double Fan Coil Unit Arrangement with Pipes Behind Curtain

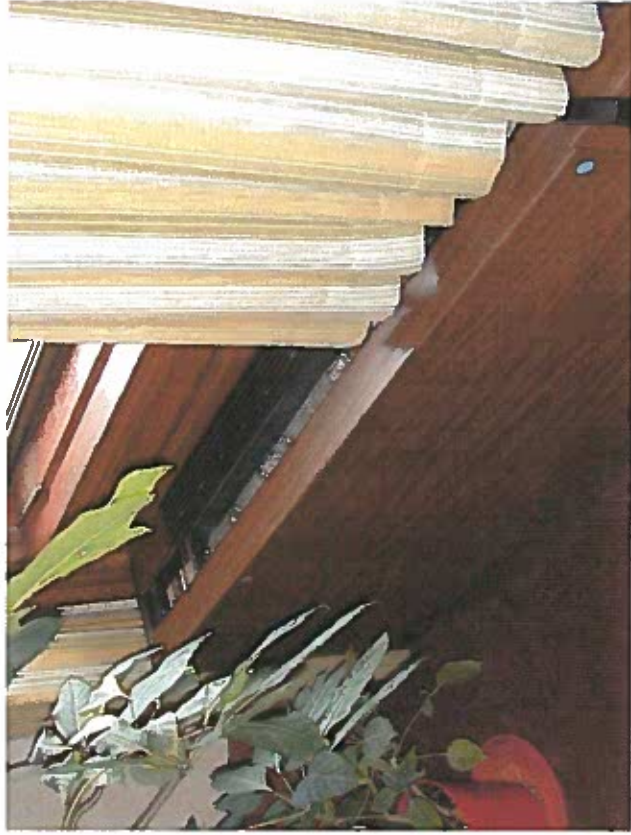
Typical Fan Coil Unit

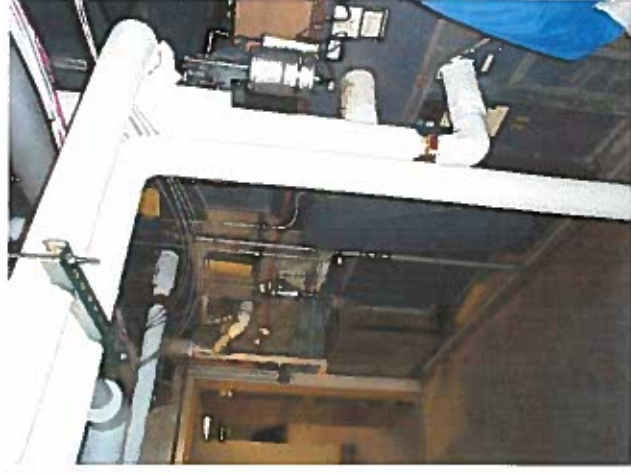
In review of the building mechanical system, it was found that the FCU and air handling units (AHU) are near the end of their service life. One AHU is over sixty years old and should definitely be replaced. The other AHU and FCUs should be replaced within five years.

Basement Air Handling Units

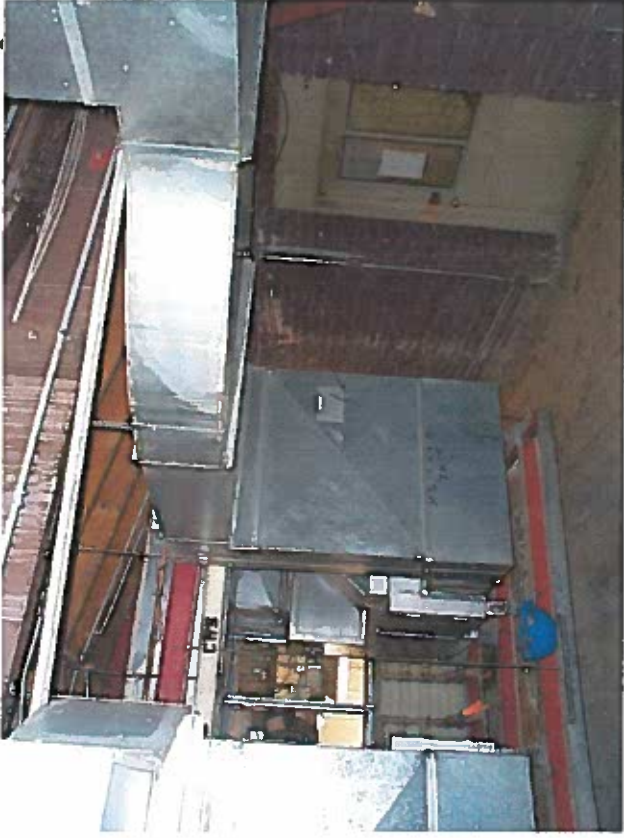
Attic Air Handling Units

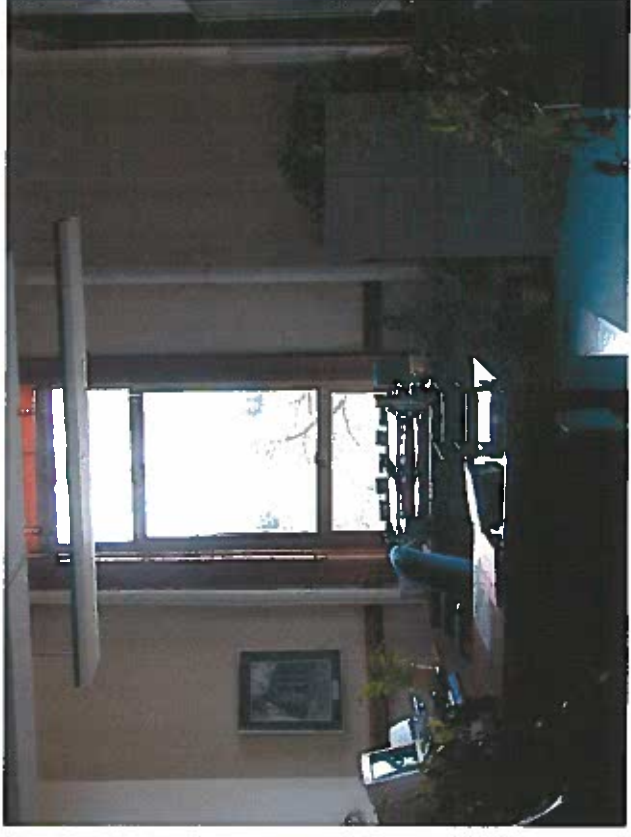
Fan Coil Unit Behind Credenza with Exposed Pipes

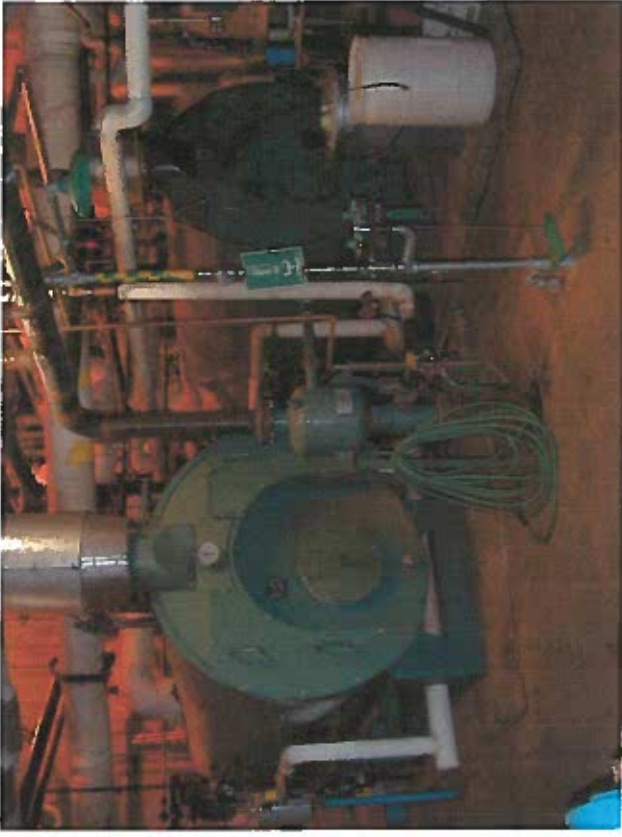
The boilers are 19 years old and are fire-tube type. The boilers were retubed in 1996 and barring any catastrophic failure they could last 10 to 20 years. The median service life of fire-tube boilers is twenty-five (25) years, however, if the equipment is well maintained, they should last over thirty (30) years.

In approximately 1985, a severe storm caused flooding of the boiler and chiller rooms. Due to the flood, the equipment in the boiler and chiller rooms needs to be closely monitored and maintained.

Boiler Room

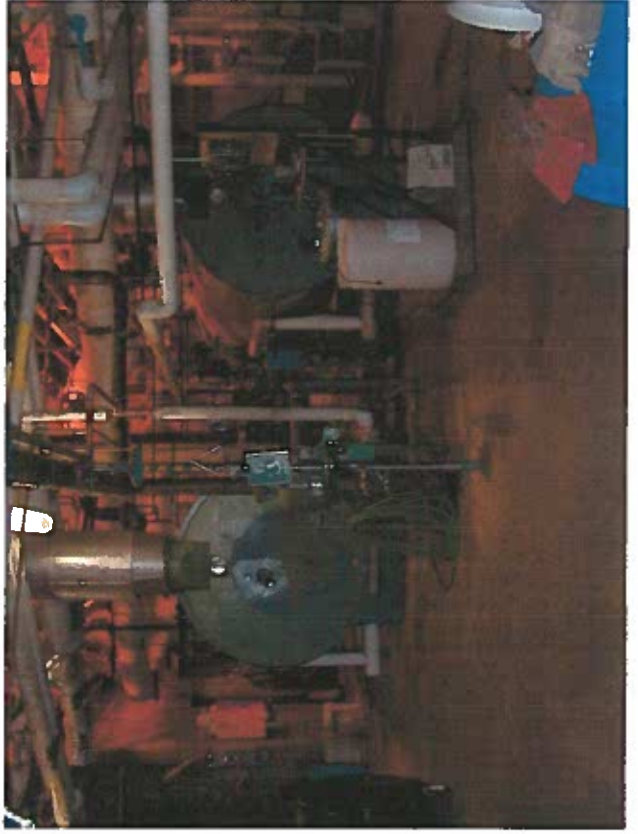
Boiler Room

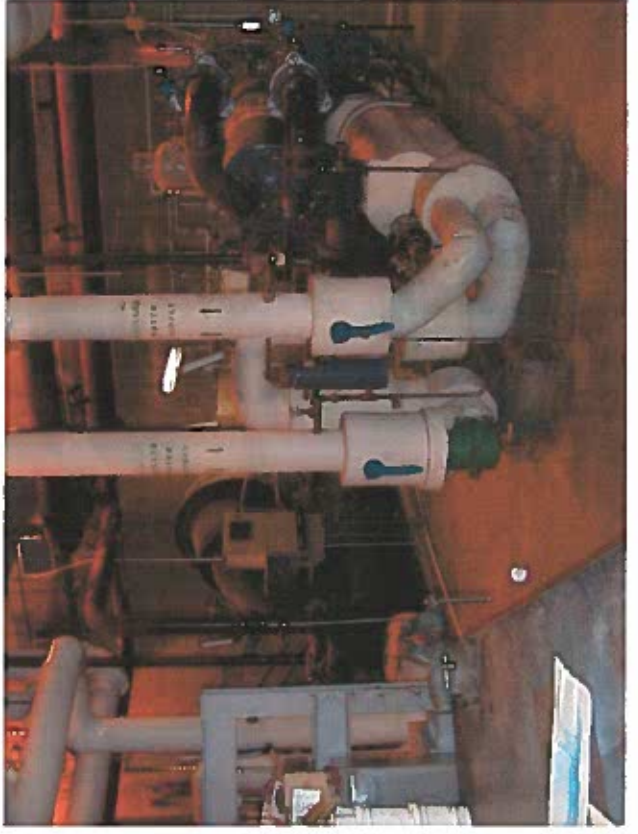
The chillers and boilers for this facility are located below the plaza between the Capitol Building and the Herschler Building. Two chillers are 19 years old and use a refrigerant no longer being manufactured due to EPA regulations. If sufficient refrigerant is available, the chillers may last up to ten more years. The median service life of these chillers is twenty-three (23) years. At this point, it is not advisable to undergo refrigerant change out. When these chillers start to show signs of significant degradation, replacement as opposed to repair is highly advised. A third chiller is in a similar situation except that it is 16 years old. The fourth chiller is only four years old and it's refrigerant has a scheduled phase out

Chiller Plant

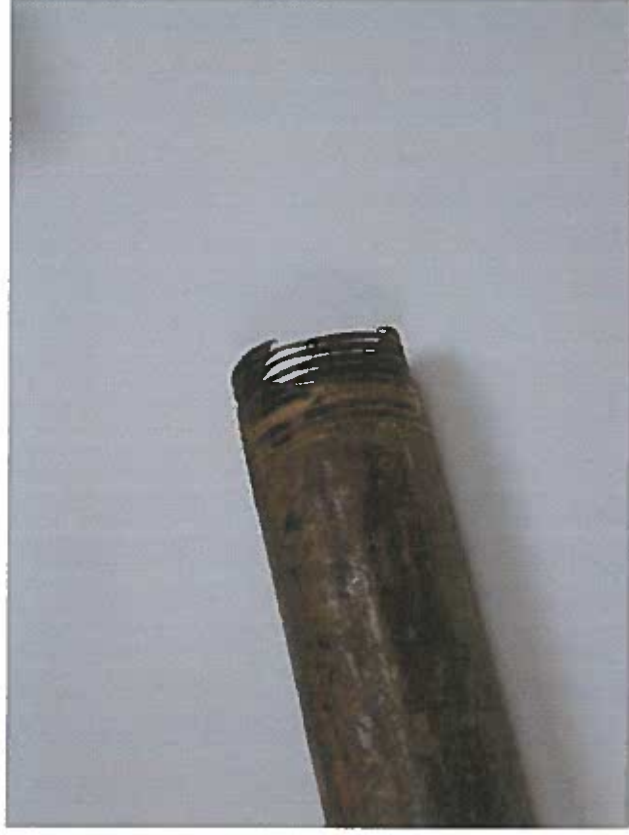
The steam condensate pipe system in the Capitol Building has been leaking at various locations. The leaks are occurring at concealed locations, which makes repairs difficult and greatly interrupts building operations. Water from the leaks can travel inside wall and ceiling cavities, which provide a breeding ground for mold. The condensate pipe system is approximately 90 years old and needs to be replaced.

The leaks are occurring at threaded joints. This often happens with pipe of this age and used for this type of service. Steam condensate can be aggressive in terms of breaking down steel pipe. Three samples of the pipe were analyzed by Summit Laboratories, Inc., 1776 East 58th Avenue, Suite E, Denver, CO 80216 to determine the cause of failure. The results indicated that at one time, chemical treatment for the boiler makeup water was potentially inadequate. Currently, the chemical treatment meets or exceeds today's standards.

Steam Condensate Pipe

Since the steam condensate system is in need of replacement, it is a good idea to replace the steam system while the building is disrupted for a significant construction effort. The likelihood of steam pipe failure is fairly high due to its age. There are two options in this replacement effort. Replace the system with a "like" system; steam and steam condensate. The second option is to install a heating hot water system.

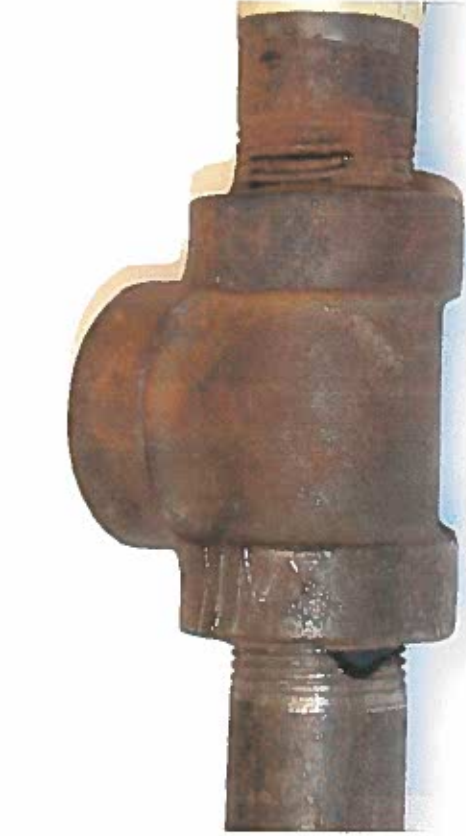
Steam Condensate Pipe

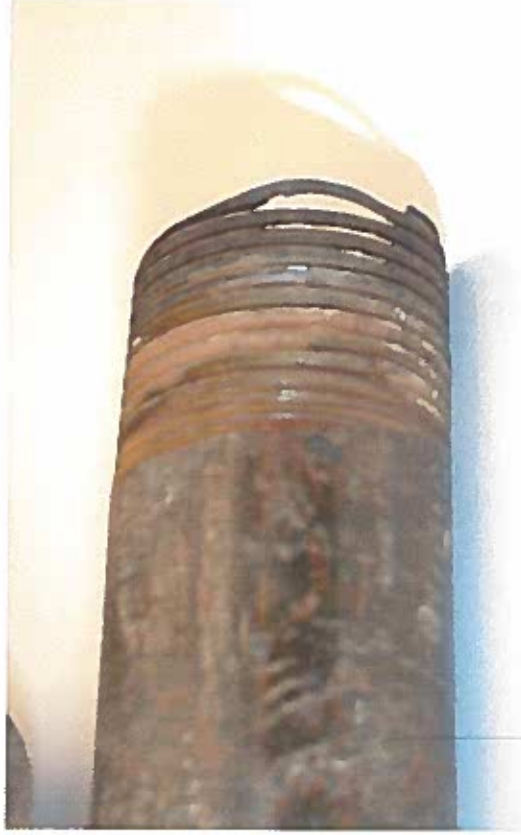
Steam Condensate Pipe
